## BASS CREEK WATERSHED (LR03)

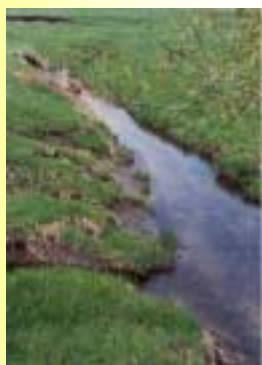
*Stevens Creek,  
straightened*

**Stevens Creek** is a small warm water stream tributary to Bass Creek near Hanover. The stream is very turbid and its flow sluggish in its lower reaches. While flow above State Highway 11 is much stronger, obvious erosion from agricultural cropland and pasture use affects the stream's water quality. The fishery consists of forage fish although fisheries managers believe the stream could sustain a trout fishery if protected. Like Bass Creek, the water quality of Stevens Creek is affected by cropland erosion, barnyard runoff, and streambank erosion. A May 1996 habitat evaluation characterized the stream's habitat at the Mineral Point Road crossing as "poor." Twenty cattle were observed standing in the stream. The stream's habitat at the Snyder Road crossing was also considered "poor." The entire 8-mile length of Stevens Creek is on the 303(d) list of impaired waters.
